REPORT NO: NAWCADPAX/TR-2000/59

BREAKDOWN OF PRESERVATIVE FLUID MIL-PRF-46170 IN AIRCRAFT HYDRAULIC SYSTEMS

NAWCADPAX/TR-2000/59
29 March 2001

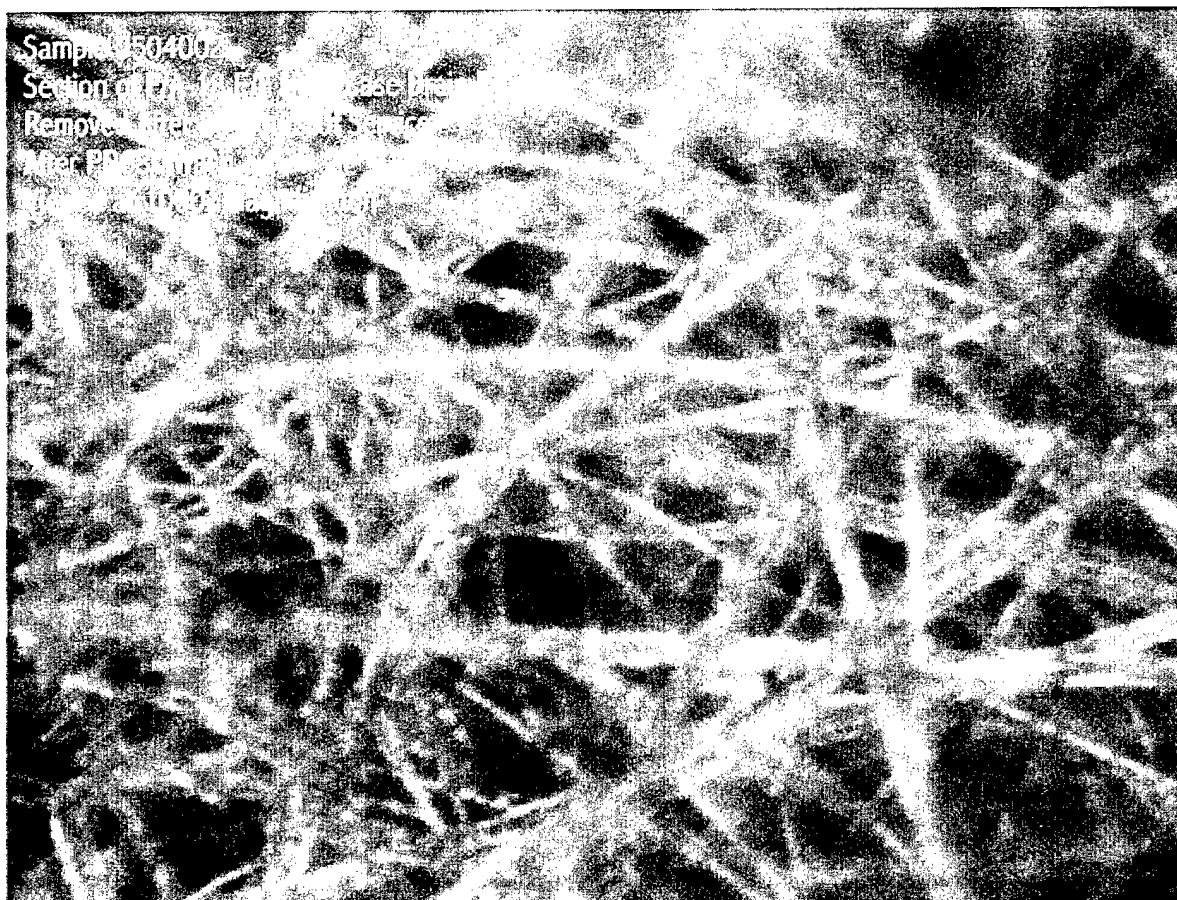
Figure A-4: F/A-18E/F Case Drain Filter With Improved HDU Motor

Inspection of filter elements removed after 59 hr of service (figure A-4) show buildup of an insoluble red organic material similar to F-14 system filters. Most fluid passages are open and filter service life has improved dramatically. The plaque buildup rate has been significantly reduced but fluid breakdown is still occurring.

Note: All filter elements inspected prior to the HDU motor redesign had dark green organic material, while current filter elements show buildup of red organic material, similar to material collecting on F-14 hydraulic system filters.

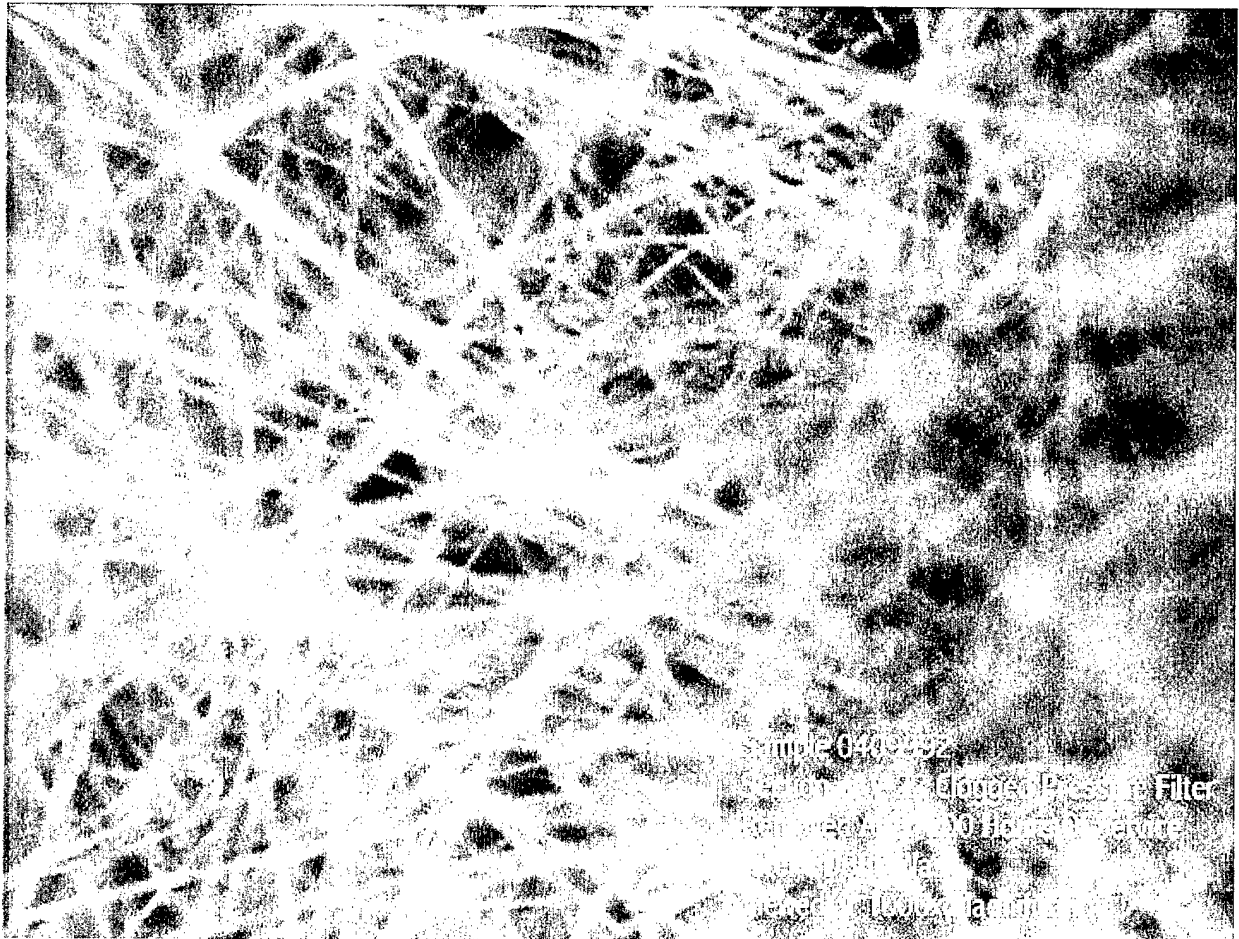
Figure A-5: V-22 Clogged Filter After Wash

elements are still in service with well over 400 flight-hours. The filter was checked to verify excessive pressure drop and identify filter debris. Most of the material was wear debris and system contaminants.

Washing the media with PD-680 removed the bulk of the material, resulting in clean light gray fibers (figure A-5). Fibers were straight and uniform with no evidence of filter plaque.
